Salt crystallization tests: Focus on their objective

A.Elena Charola^{*1}, Inge Rörig-Dalgaard², Jacek Chwast³, Jan Elsen³

Abstract

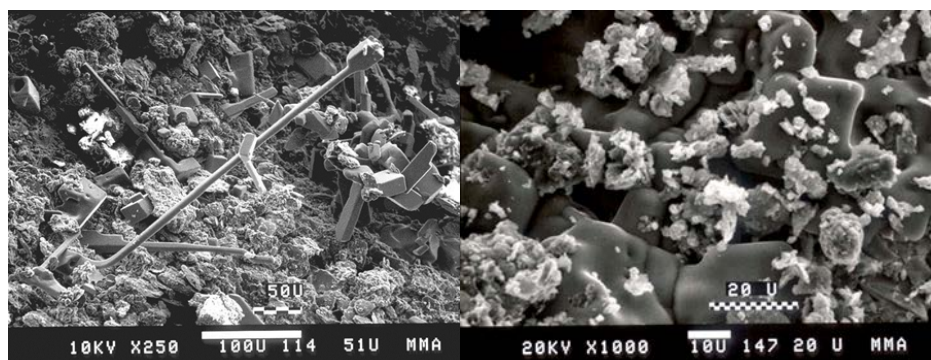
Figure 1: Left: A brick sample collected from the S.Stefano church in Venice and analyzed some years later show the change in crystal growth habit resulting from the changed environmental conditions. Right: Cubic halite crystals growing on brick from the Abbazia da Misericordia in Venice (ca. 1980), where brick powder can be seen being pushed away by the growing crystals.

Sodium chloride, halite, is probably one of the most ubiquitous salts originating both from marine environments and the use of deicing salts in northern countries [12]. This salt induces deterioration such as powdering, which is more likely to develop when isometric crystals grow, as observed on Venetian brick shown in Figure 1 left; or flaking, which in our experience can be attributed to columnar crystals growth as shown on another Venetian brick sample, Figure 1 right. This particular sample was collected in Venice but only analyzed some years later. As shown in the photomicrograph, initially NaCl formed the cubic crystals, but with the change in environmental conditions (closed sample holder) over years, the slow drying out resulted in the change of habit of the crystal growth following the pattern described by Zehnder and Arnold [7] and clearly showing that crystals grow from the bottom up.

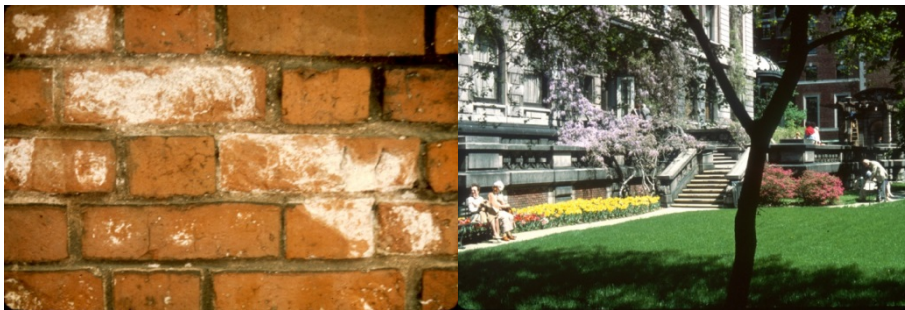
Figure 2: Detail of the brick wall showing the gypsum efflorescence formed on the parallel wall below grade to that seen in the garden at right.

A more prosaic of gypsum efflorescence was found on a brick retaining wall in the garden at the Cowper Hewitt Museum as shown in Figure 2. The gypsum, probably found in the soil of the garden on the other side of the wall, migrates solubilized in water (from watering plants and rain) through it and crystallizes out as a white efflorescence at about the top soil level on the garden side.
